Jurisdictional Delineation

**Jurisdictional Delineation Report
Los Angeles International Airport
Proposed Runway 6L-24R and Runway 6R-24L
Safety Area and Associated Improvements Project**

January 24, 2014

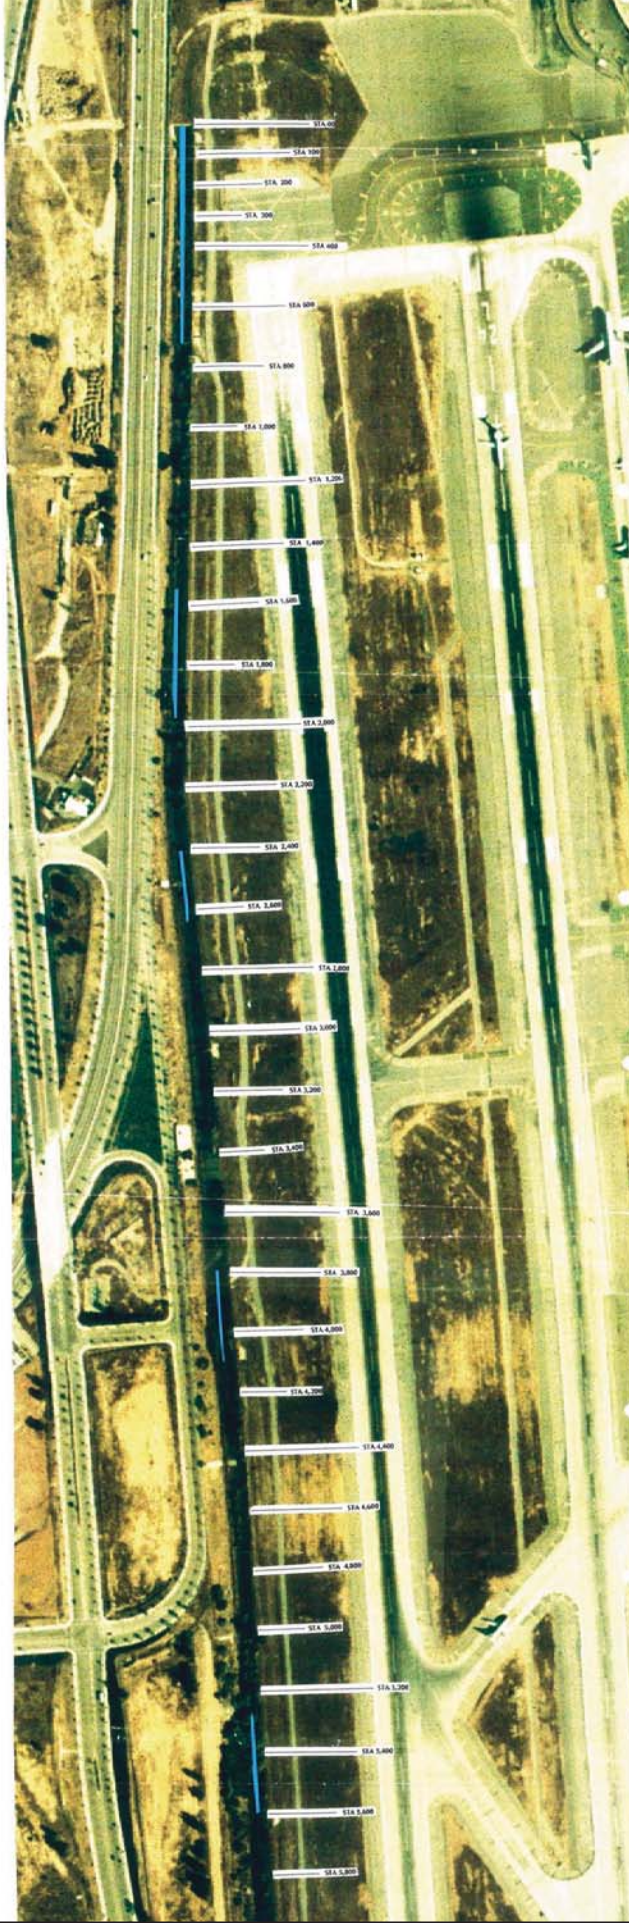
FIGURE 4.1-1
1997 Delineation of the Argo Ditch

A jurisdictional delineation of the Argo Ditch was completed in support of emergency channel maintenance activities in October 1997. Sampling occurred every 100 feet for wetland vegetation, hydrology, and soil for a total of 99 locations. During the 1997 delineation of the Argo Ditch, Sapphos Environmental, Inc. found “riparian and wetland habitat created in association with the Argo Ditch”.²⁵ Wetlands were found within the man-made ditch in limited areas (~ 1 acre in total), mostly within the eastern portions of the Argo Ditch (Figure 4.1-1, *1997 Delineation of the Argo Ditch*). Sapphos Environmental, Inc. also documented riparian vegetation dominated by willows but lacking wetlands in the mid-portions of the Argo Ditch.

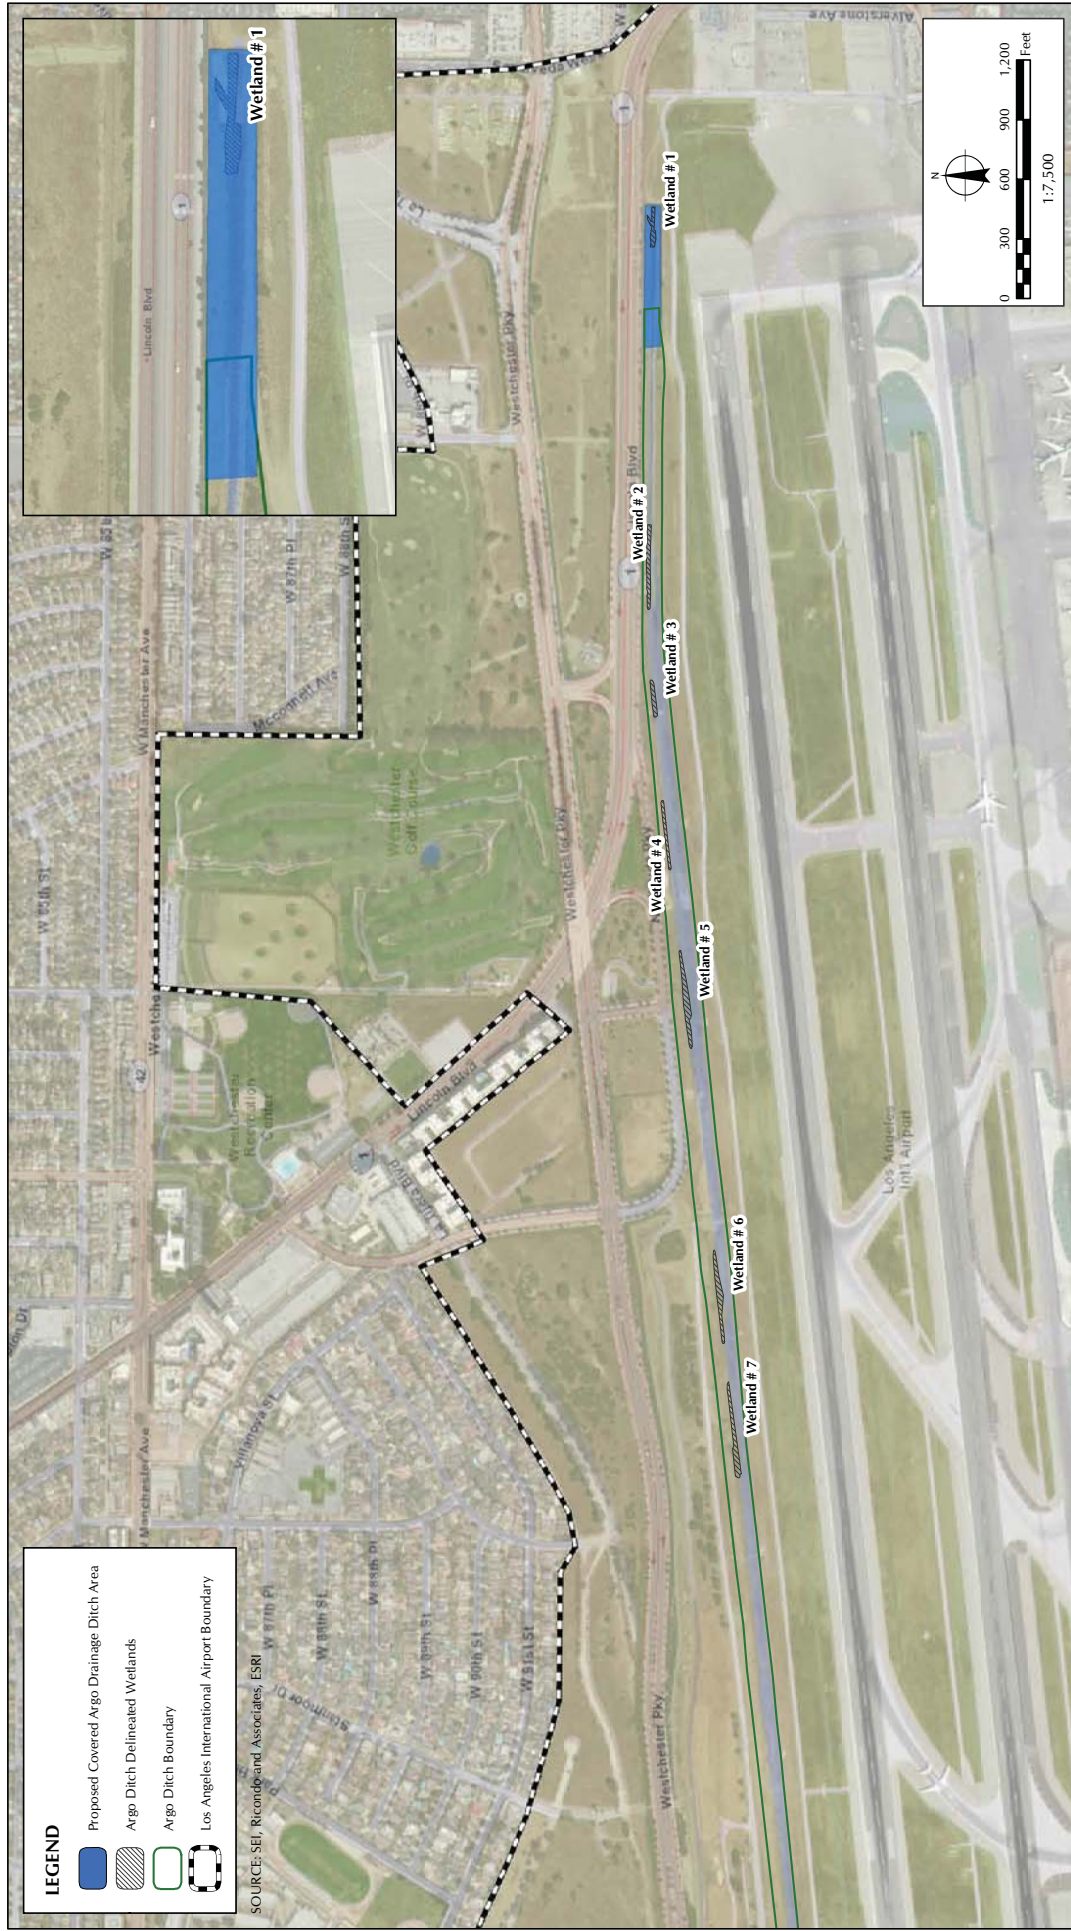
FIGURE 4.3-1
Wetlands within the Man-Made Argo Ditch

Hydrophytic Plants: The most dominant plant within this wetland was a nonnative variety of barnyard grass (*Echinochloa* sp.). Other plants detected within this wetland included native tall flat sedge (*Cyperus eragrostis*), dock-leaf smartweed (*Persicaria lapathifolia*), nonnative golden-crown grass (*Paspalum dilatatum*), perennial rye-grass (*Festuca perrenis*), and yellow bristle grass (*Setaria pumila*). The area immediately within the boxed inlet was dominated by native broad-leaf cattail (*Typha latifolia*).

Location Description: This wetland was located from 1,600 feet to 2,000 feet from the eastern end of the Argo Ditch. A concrete apron and culvert was located on the north slope of the channel between sampling points at 1,900 and 2,000 feet, where standing water was observed. Runoff from this culvert was likely a driving factor in creating this wetland. During the 1997 delineation, a wetland was documented from 1,565 to 1,994 feet from the easternmost end of the Argo Ditch.

Hydrophytic Plants: Nonnative perennial ryegrass, yellow bristle grass, and native dock-leaf smartweed were present around the edges of the wetland. Duckweed was observed within the open, standing water. Dominant plants observed within the wetter portions included nonnative barnyard grasses and native tall flat sedge and California bulrush (*Schoenoplectus californicus*).
